Unique *FT Waterproofing* Technology For Mangalore Tile Roofing Sheets

**MANGALORE TILE WATERPROOFING
PROCEDURE
AT RAILWAY HEAD OFFICE
(Churchgate Mumbai)**

MANGLORE TILE ROOFING WATERPROOFING

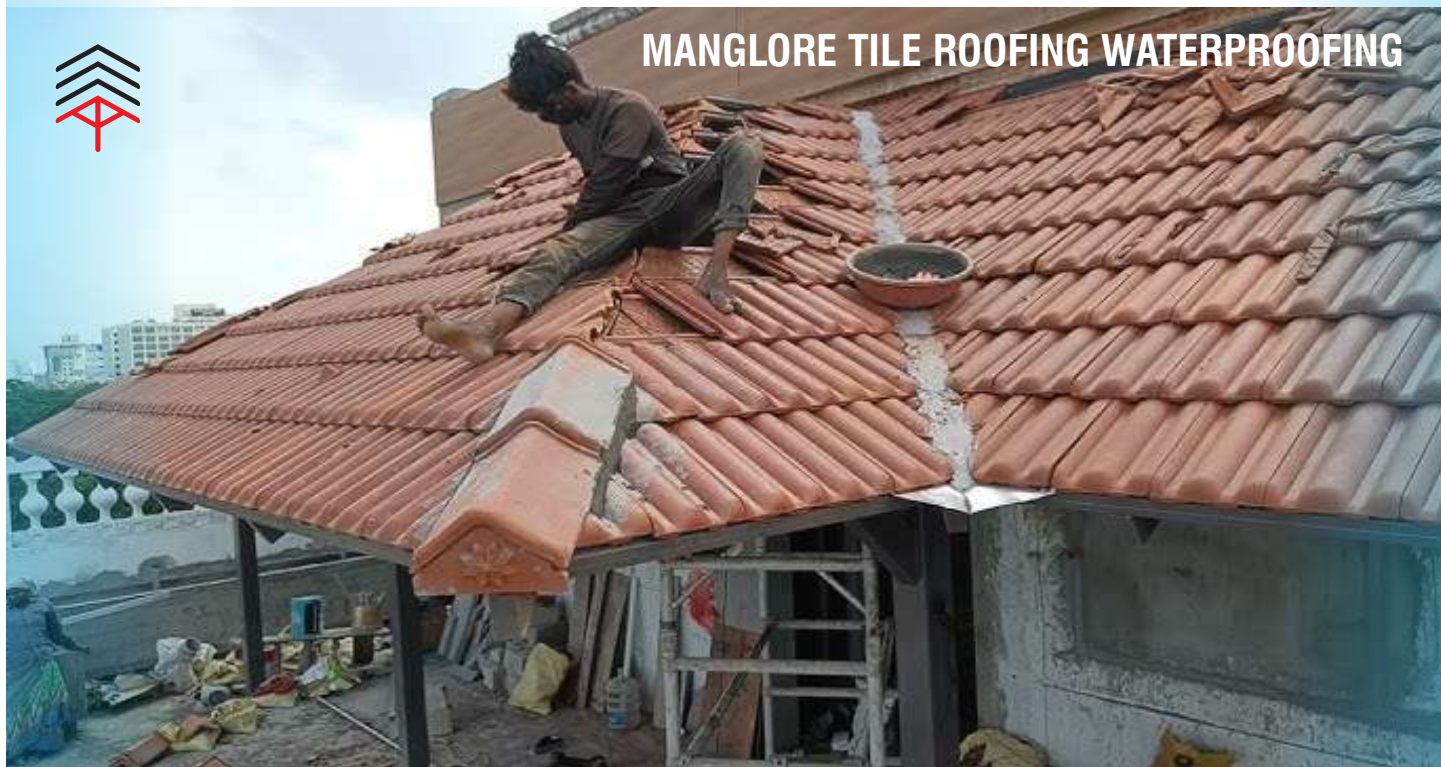
WATERPROOFING FT SYSTEM AT A GLANCE

- Clean the surface by rubbing with wire brush to remove dust, fungus, grass root, rust & loose material.
- Wash the surface with SAC® surface active chemical
- Wash with mild acid solution
- Wash with clean water
- Repair damaged tile and apply ASP-99 (Primer) to get an even surface & strength.
- Cut a piece of fabric as per the required size for reinforcement.
- Put the fabric on the tile and stick it with glue.
- After 40-50 minutes apply a coat of AWC-99 on the surface by brush and let it dry for one hour give one more coat of WAC-99R on the surface.
- Let it dry for 24 hours for full strength.
